Inuvik -Tuktoyaktuk Highway Update

ITH Update – 29 May 2018

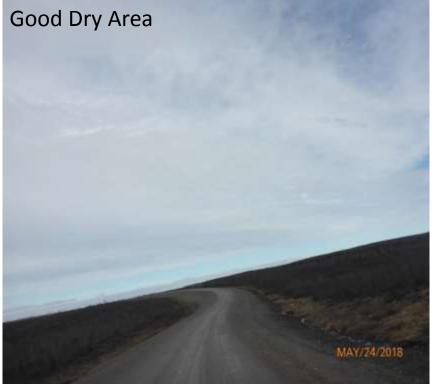
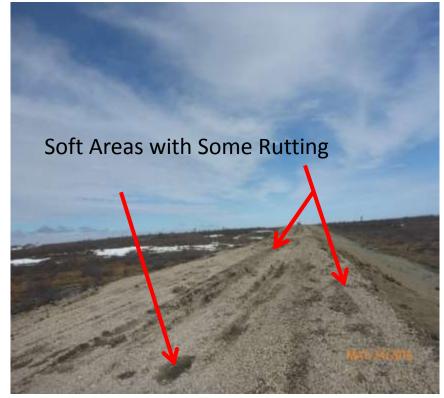
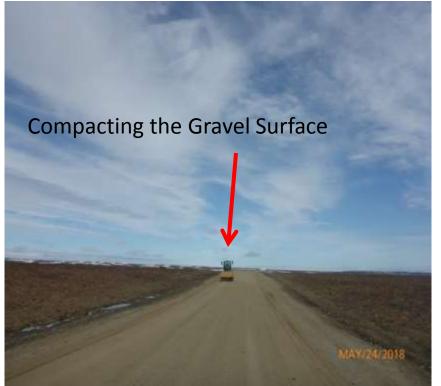
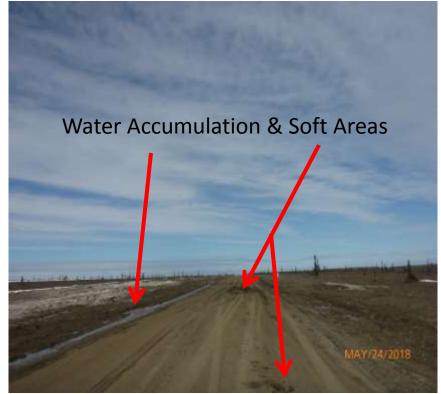
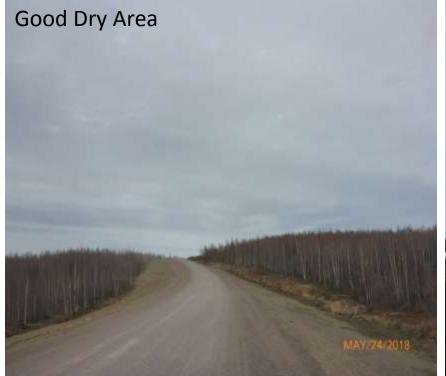
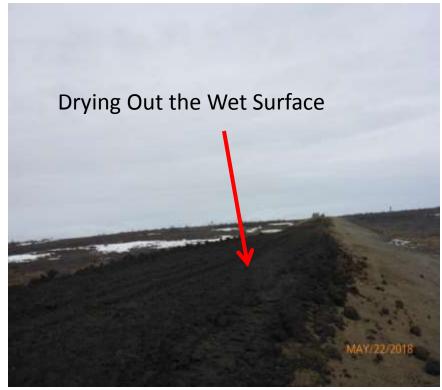
- Restricted traffic 27 April traffic on the hwy midnight to noon and no traffic noon to midnight. Worked until unauthorized vehicles rutted road causing safety concerns
- Temporarily closed 12 May for safety and preservation
- 4 sections, totaling 5.5km, in the area km 21-44 remain soft
- All other areas performing very well
- INF staff and Contractor working on the areas

- Km 122-138 slippery when wet but trafficable
- Once these repairs completed and weather remains dry the highway can be reopened with restrictions
- Expected date of reopening is 31 May 2018 if weather conditions permit
